## Patient Safety Tip of the Week

November 21, 2023

### Another Terrifying MRI Accident

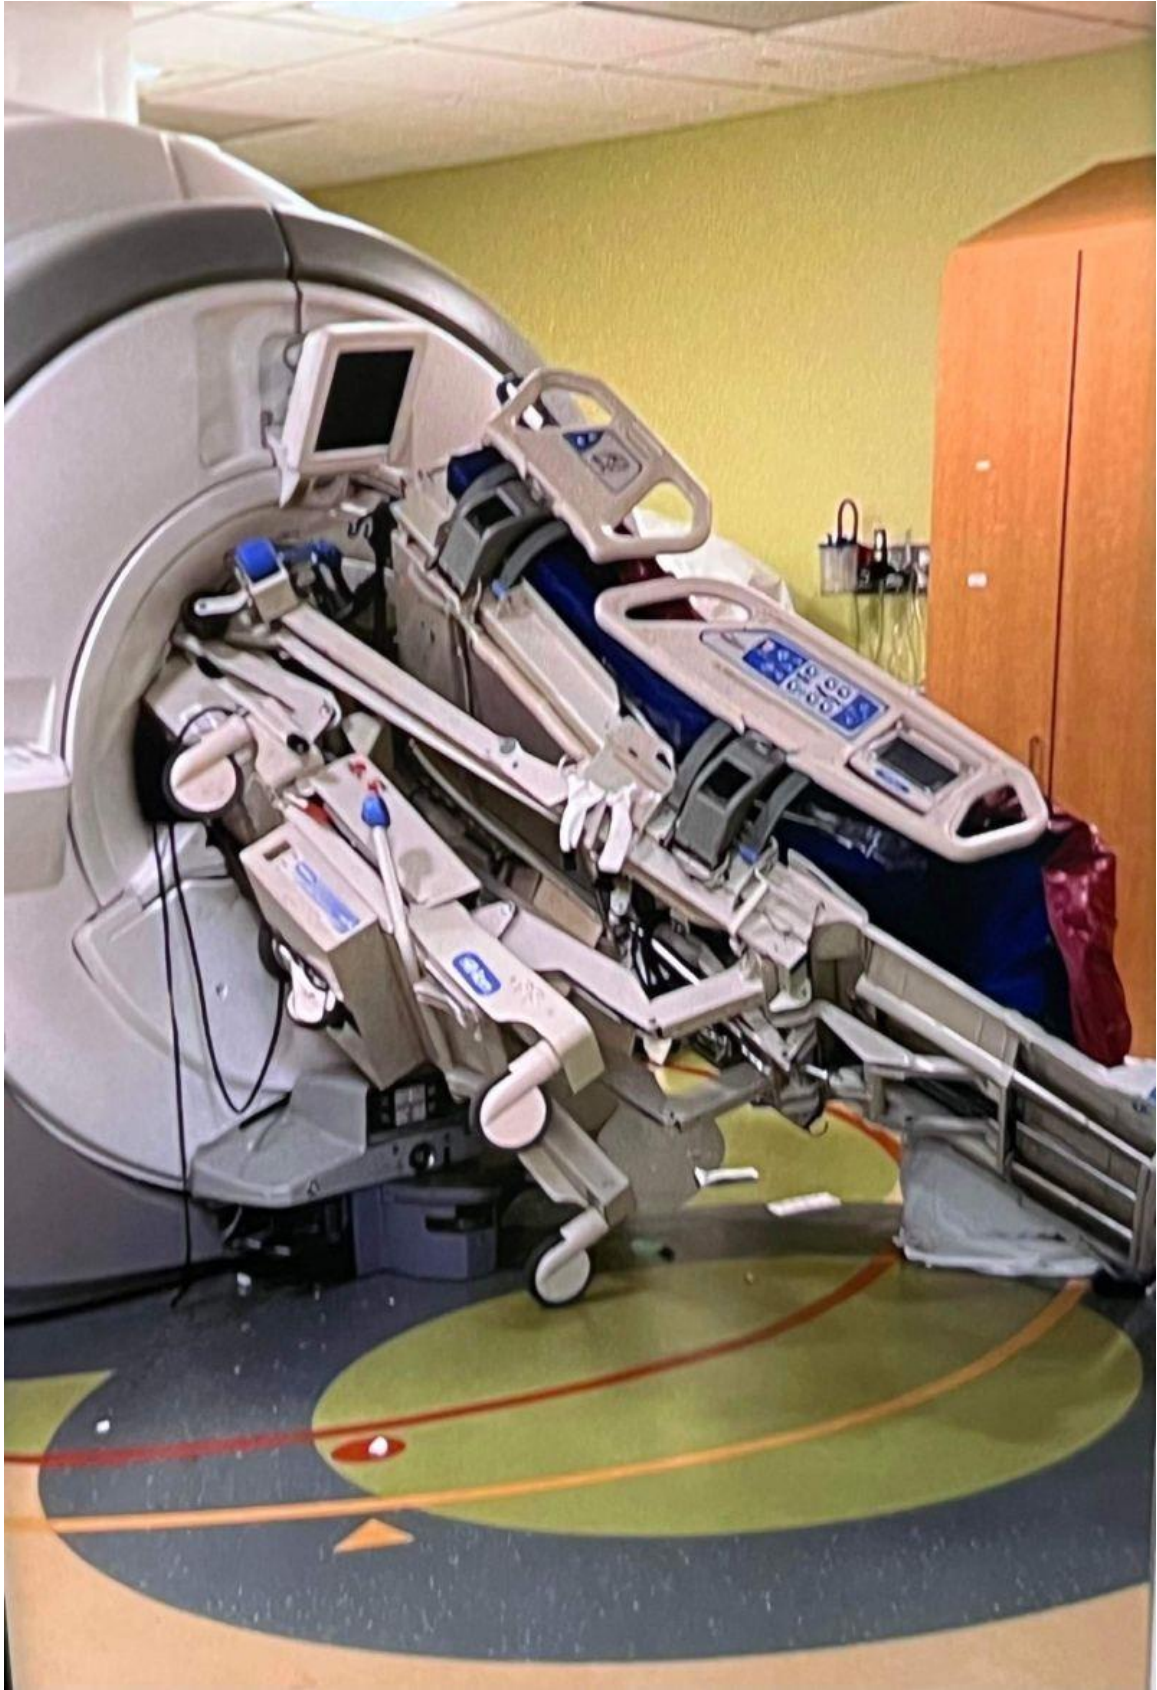
The nurse was in the preparation area with a patient and another nurse. A door between that area and the MRI room should have been closed but was open. Once the patient was prepped, the nurse began to move the bed toward the door to the MRI room. However, the door was open, and as the nurse got closer to the door with the metal bed, she and the bed were suddenly flung toward the machine, pinning her between the machine and bed.

KTVU reported the nurse said “I was getting pushed by the bed” and “Basically, I was running backwards. If I didn't run, the bed would smash me underneath.” An MRI technologist had just finished a call and heard screaming coming from another room. The photo below shows the bed sucked into the MRI machine. It is incredible that someone did not die in this accident.

A report from the California Division of Occupational Safety and Health (Cal/OSHA) notes that the nurse and patient care tech were left unsupervised without MRI personnel. No one, including the patient, was ever screened. The door to the magnetic room was left open. And the safety alarm system never sounded. In addition, some employees had not received required safety training and the hospital had failed to annually test the door alarm as recommended.
